NAVAL RESEARCH LAB WASHINGTON DC
ENGINEERING PHYSICS OF DIELECTRICS. (U)
OCT 53 A T MCCLINTON, H RABIN, E L BRANCATO
NRL-MR-218

(6) ENGINEERING PHYSICS OF DIELECTRICS.

(9) Progress Report No. 2

(11) 1 October 1953

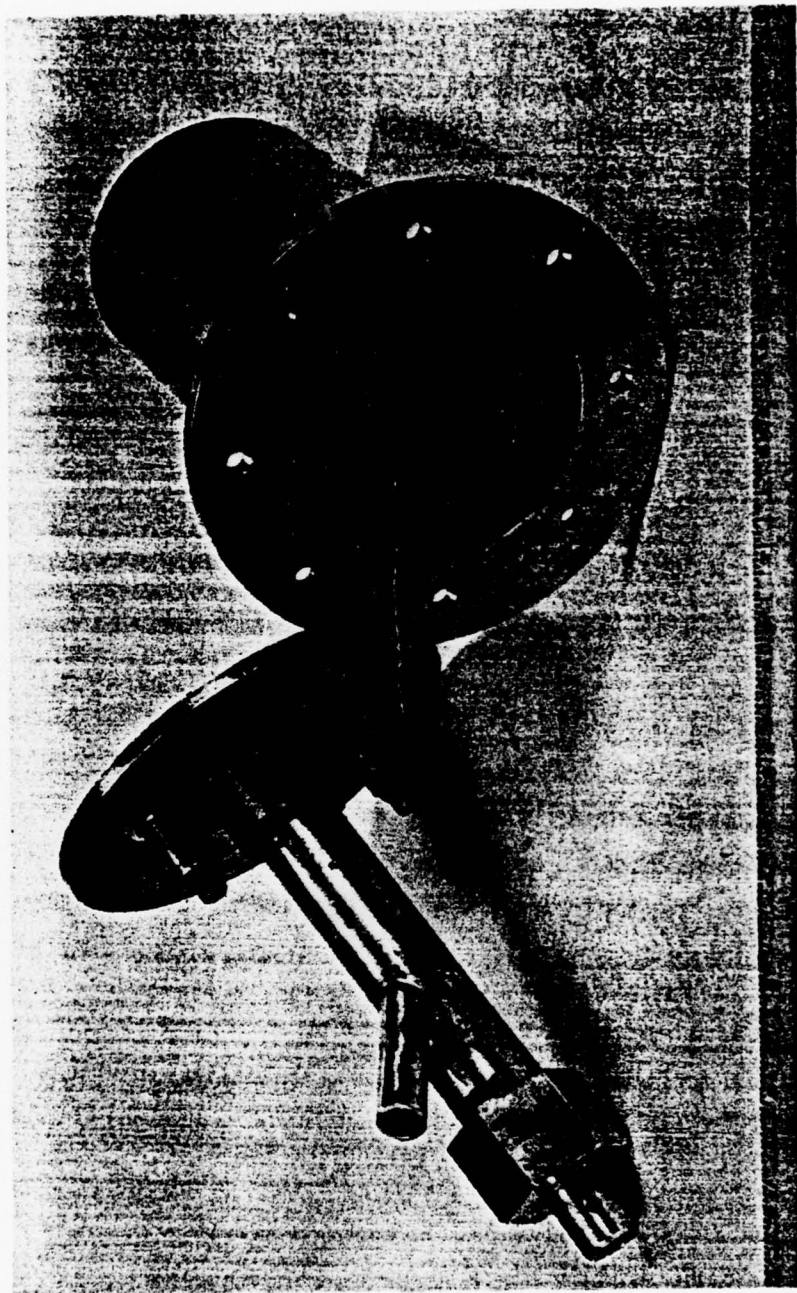
Figure 7. Open Inner Test Cell.

The inner test cell is designed to permit continuous electrical measurements of dielectric specimens. Electrical leads may be brought through the angled extension at the top of the unit to a sample holder which supports the dielectric within the cell. The cell is constructed of stainless steel and it has a wall thickness of $1/32$ of an inch. It is provided with a pin arrangement, of the same design as that located at the base of the source cans, to position the cell with respect to angle in the central hole of the source plate. A view of the opened inner test cell is shown in Figure 7.

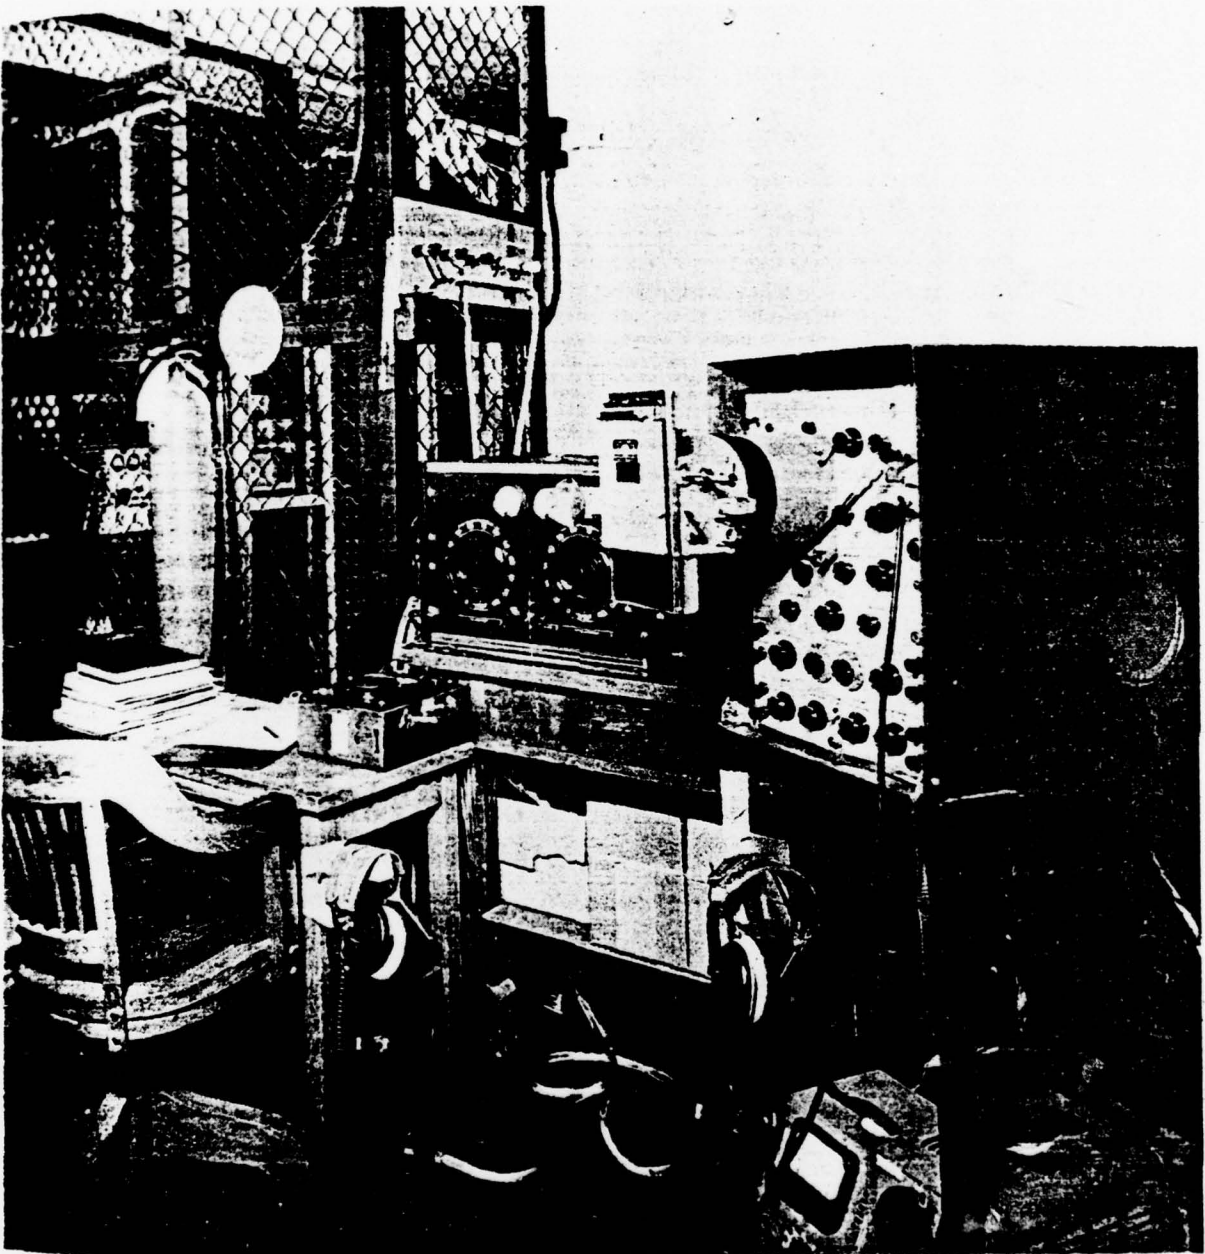
Figure 28. Impulse generator control area and the oscillograph.
